## Analysis of STS-134 Hail Event at Pad 39A, March 30, 2011

ESC-QNA(EASi)  
Kennedy Space Center, FL  
[John.E.Lane@nasa.gov](mailto:John.E.Lane@nasa.gov)

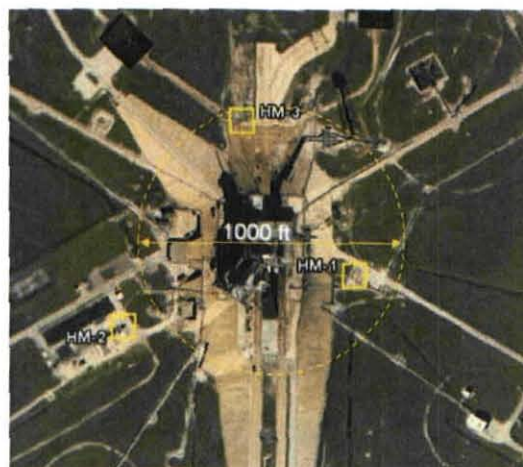
Figure 4 shows the location of the three hail monitor systems. These systems are generally deployed a few days before roll-out and retrieved a few days before launch. Due to a hazardous operation at the time of deployment for STS-134, the location of hail monitor #2 was at an alternate site, 135 ft NW of the site shown in Figure 4.

Figure 4. Location of three hail monitor stations, approximately 500 ft from pad center.

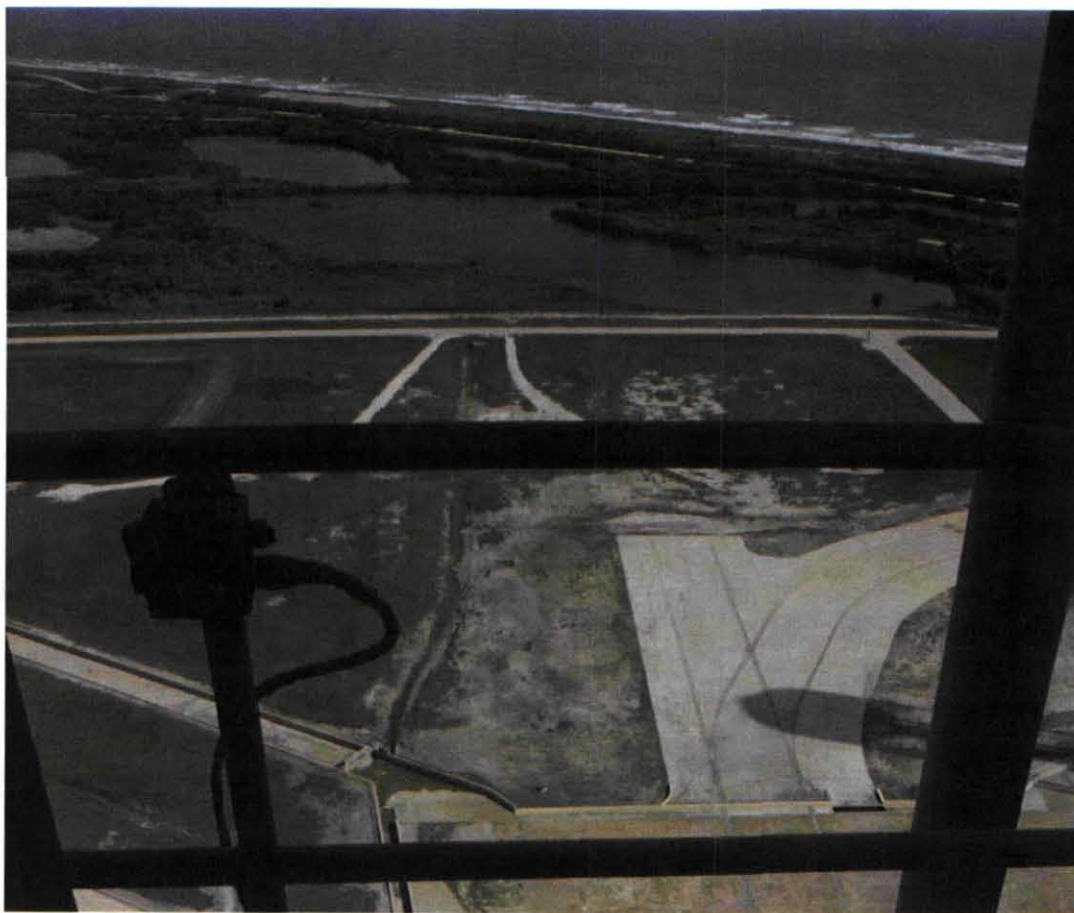
*Figure 7. FSS 275 level view of hail monitor at site #3, bottom center of image.*

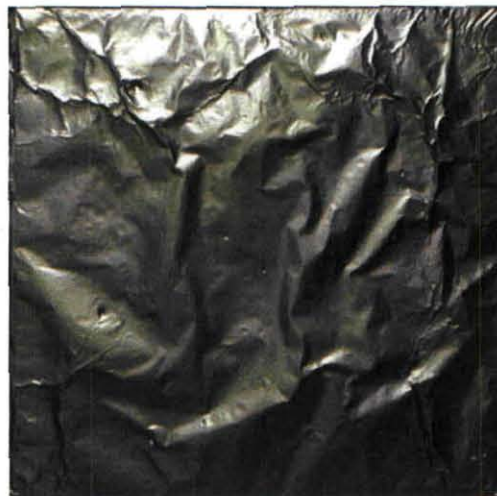
Figure 8b. Passive hail pad showing small dents.

Site #1 on the east leeward side was shielded from the west wind by the pad structure and therefore shows a smaller total flux of hail, even though the sizes generally agree with the other two stations. Based on the behavior of the active sensor data, it would appear that the channel #1 response has drifted beyond the cut-off response of the system. This behavior can possibly be explained by weather and aging degradation of the system calibration.

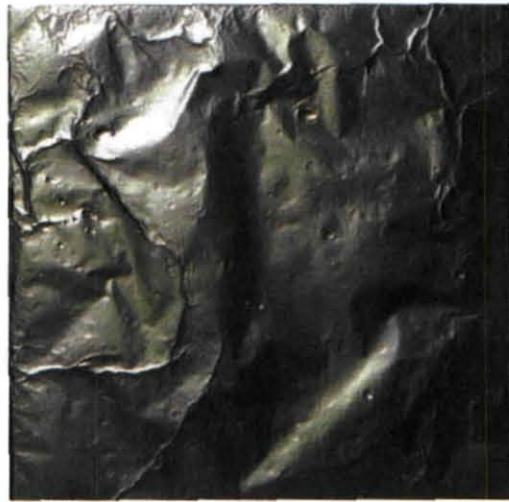
Figure 9b. Passive hail pad showing small dents.

Site #2 shows the most action which is expected since it received the full force of the storm on the windward side of the pad. Several impacts are counted as 10-12 mm impulses, but are likely overestimating size due to extra kinetic energy gain from the high horizontal winds.

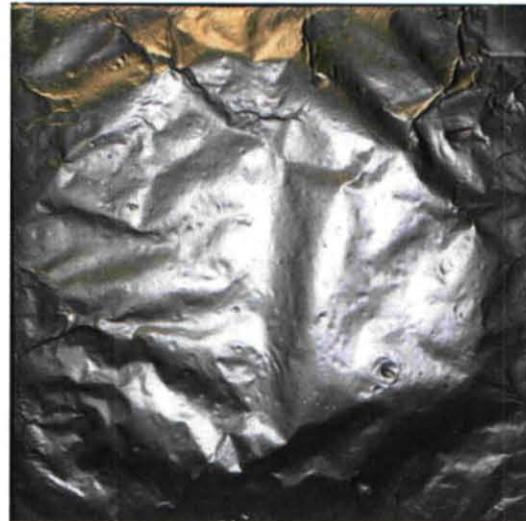
Figure 10a. Time of active sensor impulse. Figure 10b. Passive hail pad showing small dents.

Site #3 shows slightly larger dents in the hail pad than site #2, but no response from the active sensor. In this case, it is believed that a cable vibrated loose, resulting in no counts from the electronic sensor.
